Reclamation District 799

DISTRICT ENGINEER REPAIR MEMO

Subject: Placement of Levee Embankment Fill Material to Repair Localized Slope Failure and Dry Surface Holes or Exposed Voids caused by Small Animals and Rodents

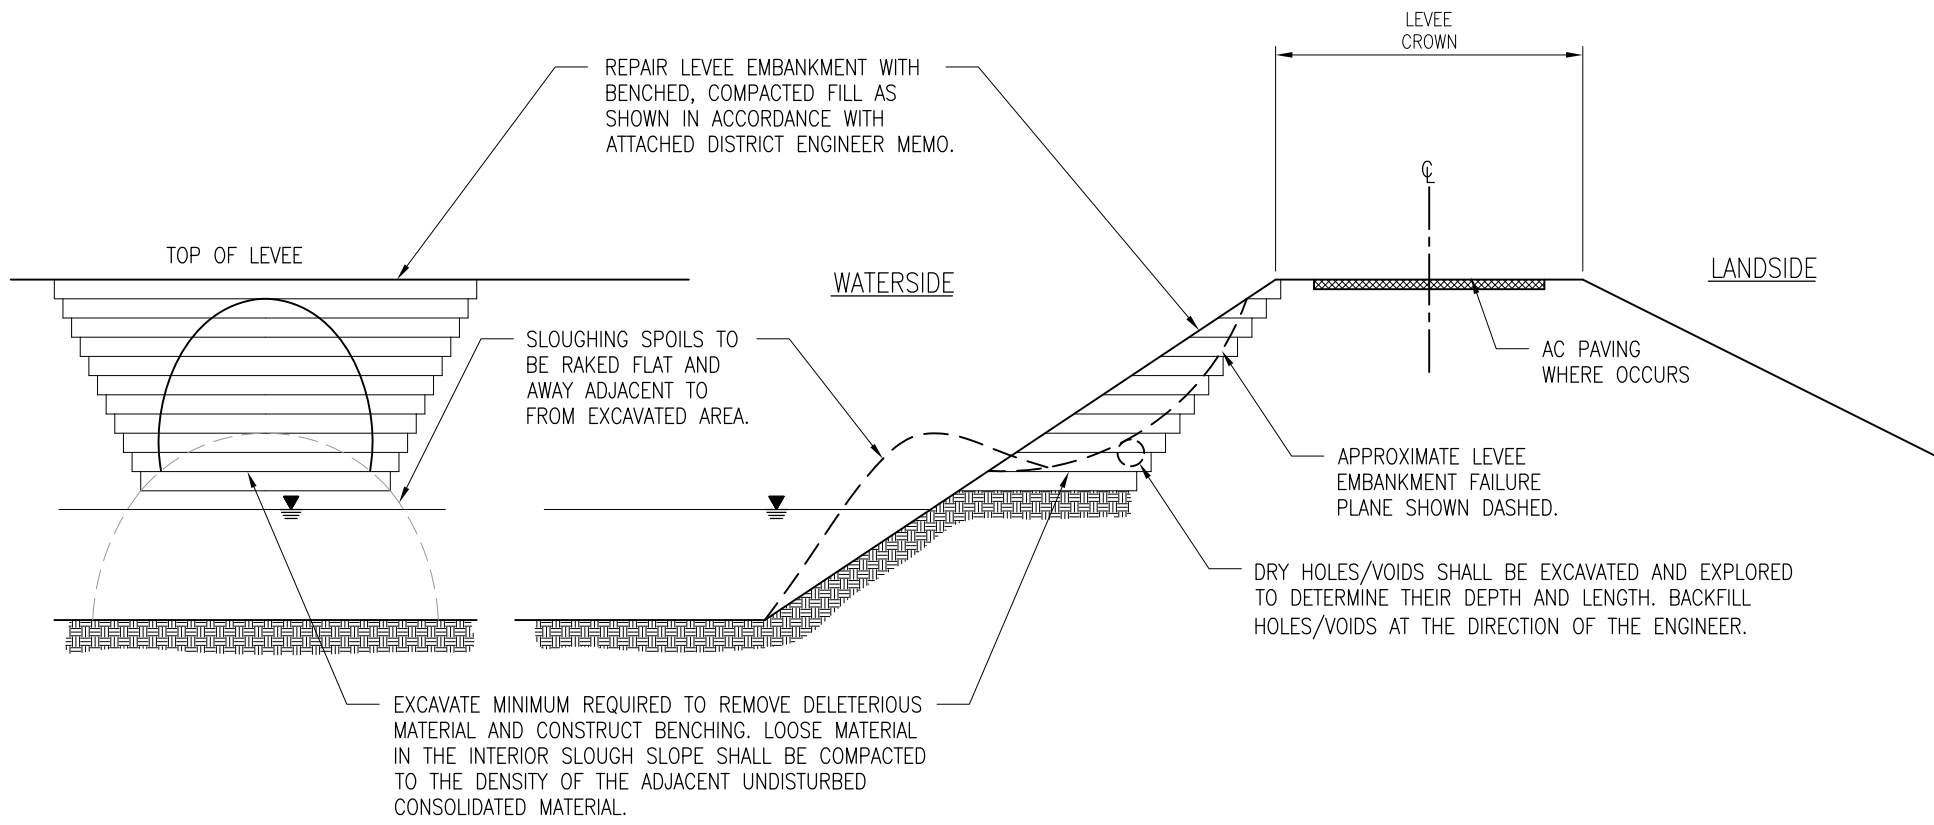
<p>REPAIR OF EMBANKMENT FAILURE FILL PLACEMENT</p> <p>RECLAMATION DISTRICT 799</p>	<p>DATE:</p> <p>OCTOBER 2010</p>
	<p>FIGURE:</p> <p>LR-1</p>

1. STRIP ALL VEGETATION AND ORGANIC MATERIAL AWAY FROM REPAIR AREA.
2. DO NOT REUSE SLOUGHING SPOILS AS LEVEE EMBANKMENT FILL MATERIAL.
3. PLACE ROCK SLOPE PROTECTION ON WATERSIDE LEVEE SLOPE IN ACCORDANCE WITH ATTACHED FIGURE.
4. HOLES/VOIDS THAT RUN PARALLEL WITH AND DAYLIGHT ON THE LEVEE SLOPE ARE LESS THAN 2- FEET BELOW GROUND SHALL BE EXCAVATED AND REPAIRED IN ACCORDANCE WITH THIS REPAIR PROCEDURE.

- Holes and voids that run parallel with and daylight on the levee slope and are less than 2-feet below ground shall be excavated and repaired.
- Reuse of sloughing spoils as levee embankment fill material is not allowed.

- density as measured by ASTM Method D1557 (testing by others) and a minimum 95% relative compaction for the top 2 feet below the levee crown.
- b) Fill material shall be tied into existing levee embankment (benched) with 8 inch vertical by 8 inch minimum horizontal steps.

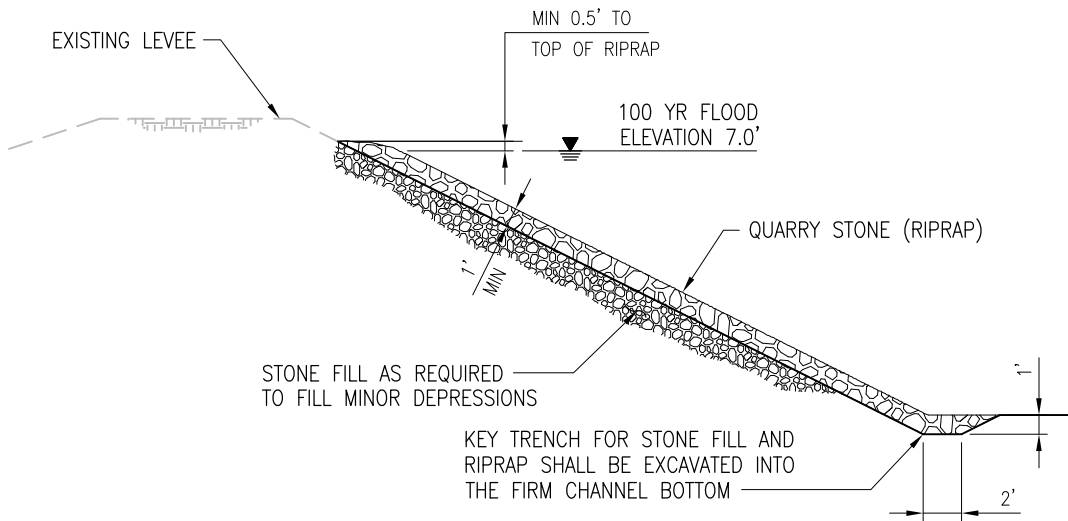
RECOMMENDED QUARRY STONE GRADUATIONS AND STONE FILL SIZES ARE AS FOLLOWS

1. PRIOR TO PLACEMENT OF STONEFILL OR STONE PROTECTION (RIPRAP), LOOSE MATERIAL IN THE LEVEE BANK SLOPE SHALL BE COMPACTED TO THE DENSITY OF THE ADJACENT UNDISTURBED CONSOLIDATED MATERIAL.
2. STONE FILL SHALL CONSIST OF BANK RUN GRAVELS, DREDGE TRAILINGS, QUARRY WASTE (OTHER THAN OVERBURDEN AND STRIPPING) AND/OR BANK PROTECTION STONE.
3. QUARRY STONE SHALL BE ANGULAR IN SHAPE. NEITHER THE BREADTH OR THE THICKNESS OF ANY PIECE OF STONE SHALL BE LESS THAN ONE-THIRD ITS LENGTH.

Repaired levee slope shall be observed by district representative prior to the placement of rock slope protection. Rock slope protection per district standards shall be applied over the completed slope repair. For any fill placement, the following is required:
